SPECIAL
RADIO SERVICE
BULLETINS

THOMAS A EDISON, INC.
ORANGE N.J.

SPECIAL SERVICE BULLETIN FOR EDISON RADIO SERVICE ENGINEERS

SUBJECT: "Elimination or the reduction of hum level in JR and JC chassis."

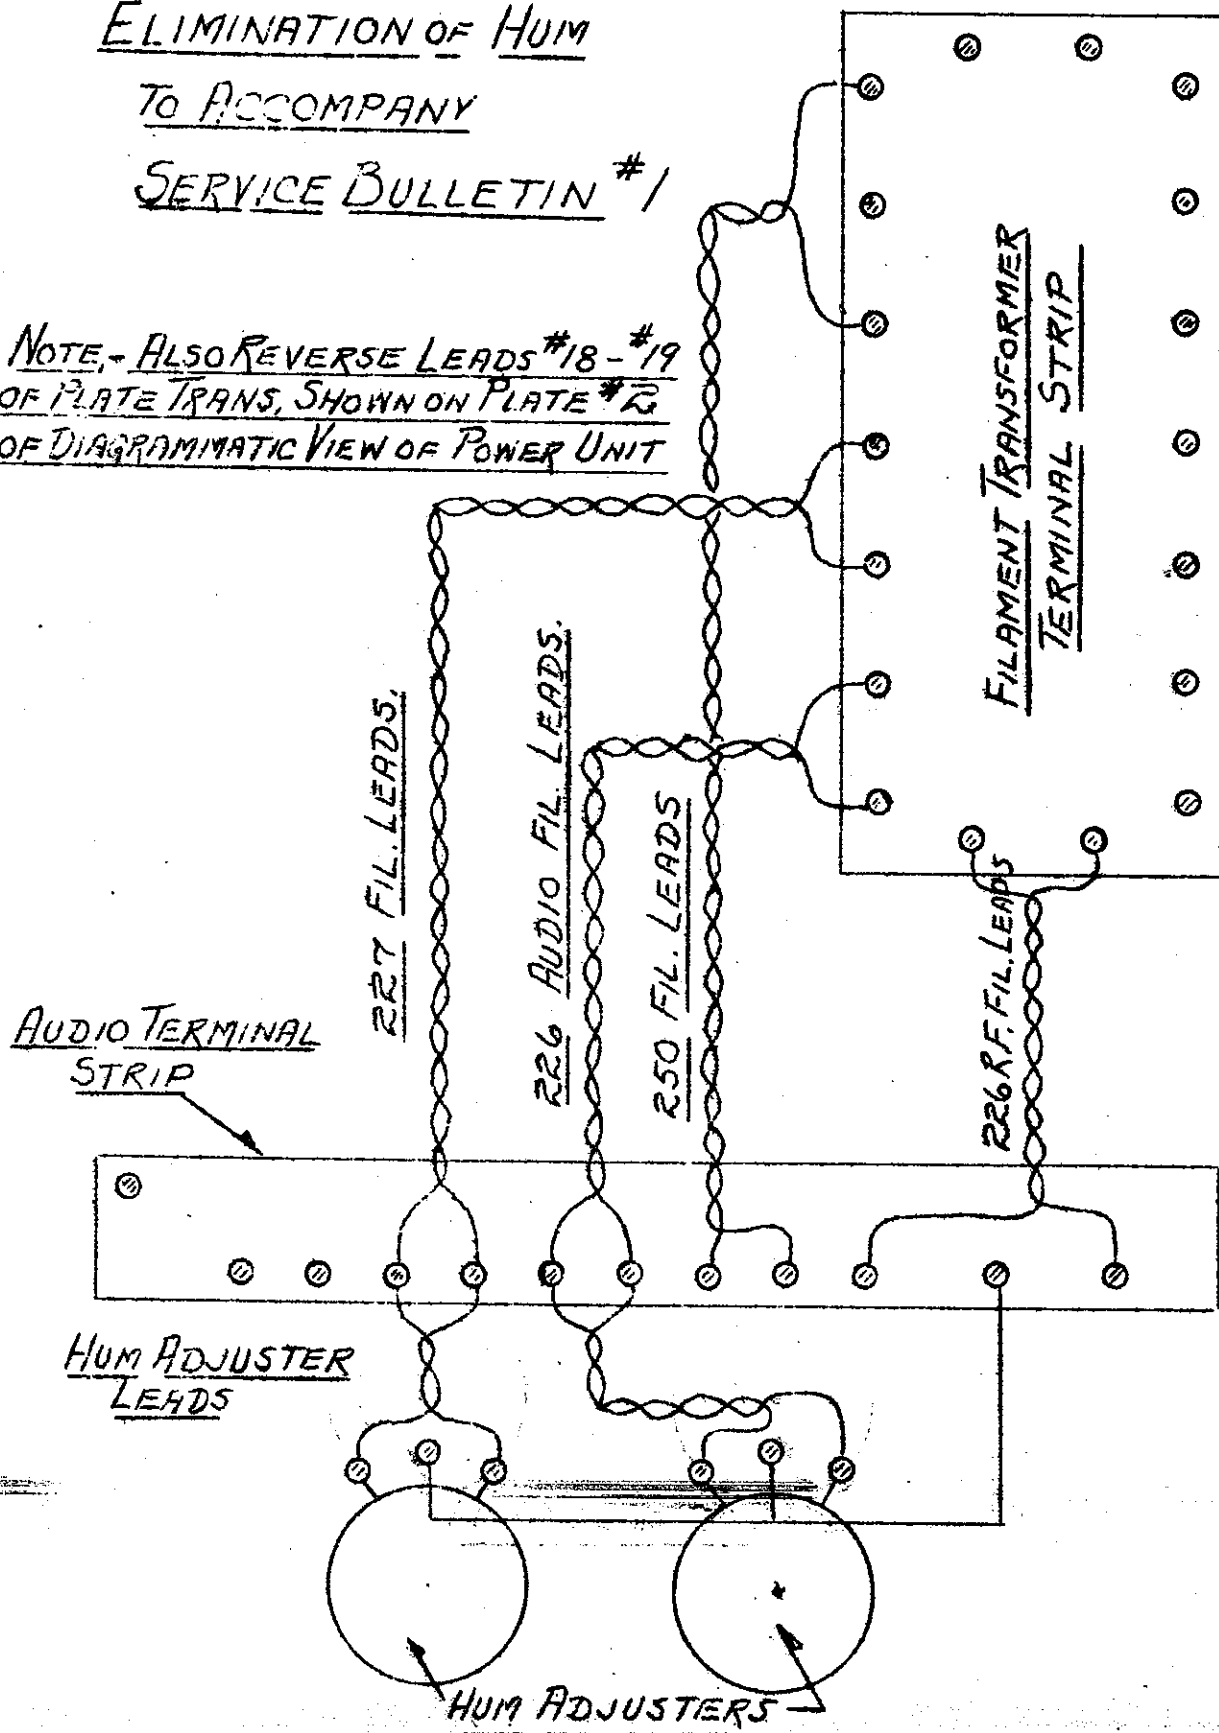
ELIMINATION OF HUM
TO ACCOMPANY
SERVICE BULLETIN #1

NOTE, - ALSO REVERSE LEADS #18 - #19
OF PLATE TRANS, SHOWN ON PLATE #2
OF DIAGRAMMATIC VIEW OF POWER UNIT

1. Remove power pack unit from chassis.
2. Reverse the secondary leads on the plate (power) transformer. With the power pack in it's normal position you will find these leads at the lower, bottom end of terminal board. The terminal lug at extreme bottom has attached to it two leads, one green covered wire and a yellow wire with red tracer, remove both of these leads and place them on the terminal just above and next to lowest terminal. Of course, placing the lead from second terminal on lowest terminal.

8. It is advisable, because of color code used in cable from audio unit to power pack unit, to replace all these cable leads. Then, removing the R.F. (red) 226 filament leads, that is unsolder them at transformer terminal block, pull them back along cable route, twist then and replace in regular position, soldering them to same terminals on transformer terminal block.

9. In the same manner twist the 227 detector filament leads.
10. In the same manner twist the 226 audio filament leads.

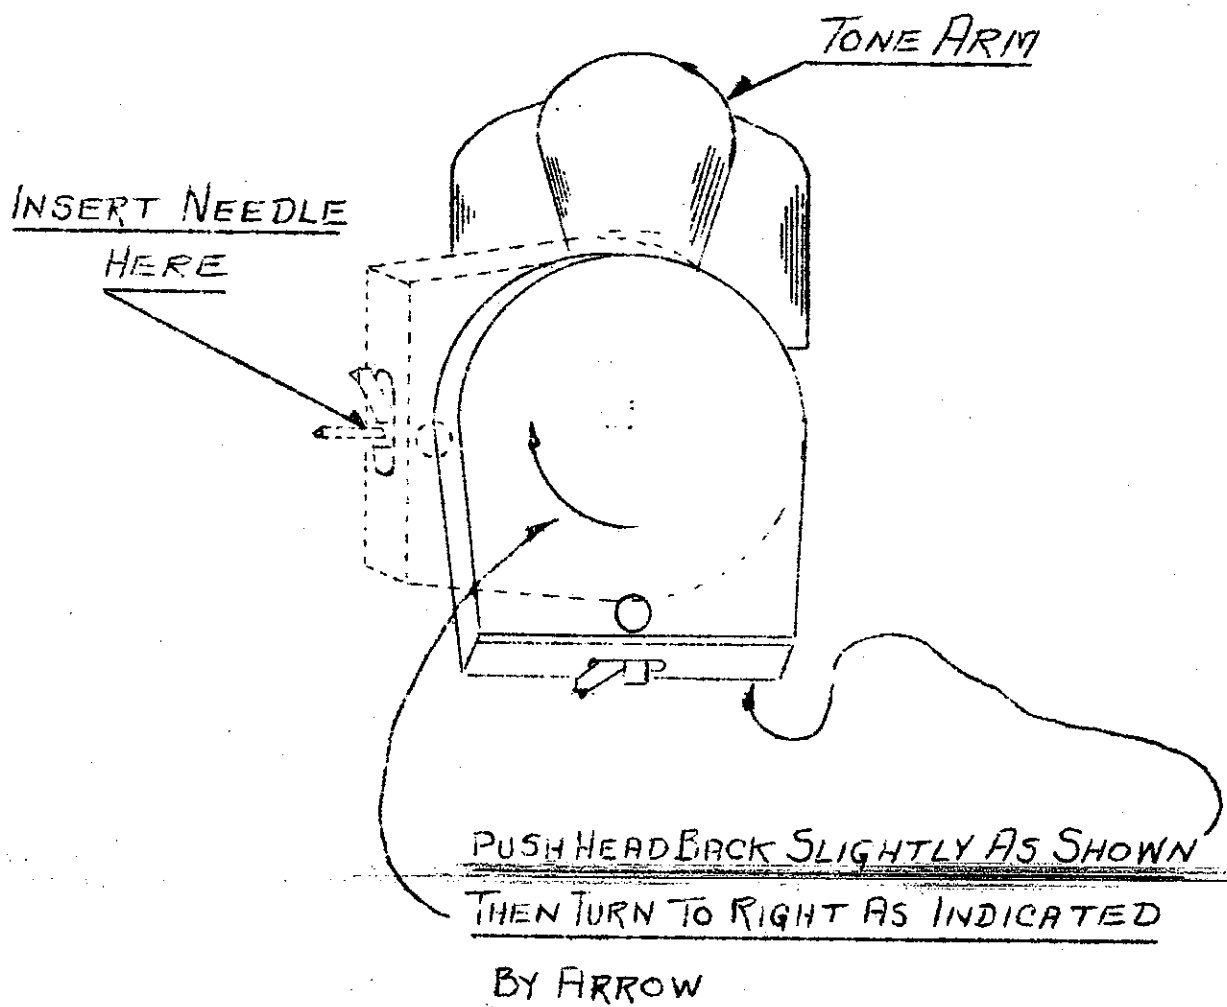
TO ACCOMPANY BULLETIN # 5

- (a) NEEDLES LOOSE IN ARMATURE. This will make the music weak and of very poor quality and will introduce an excessive amount of scratch. This trouble sometimes appears if a needle has been broken off in the armature or if the armature hole has become partially plugged with some other substance, which prevents the new needle from being introduced to its correct position.

HOW TO INSERT NEEDLE IN PICK-UP HEAD

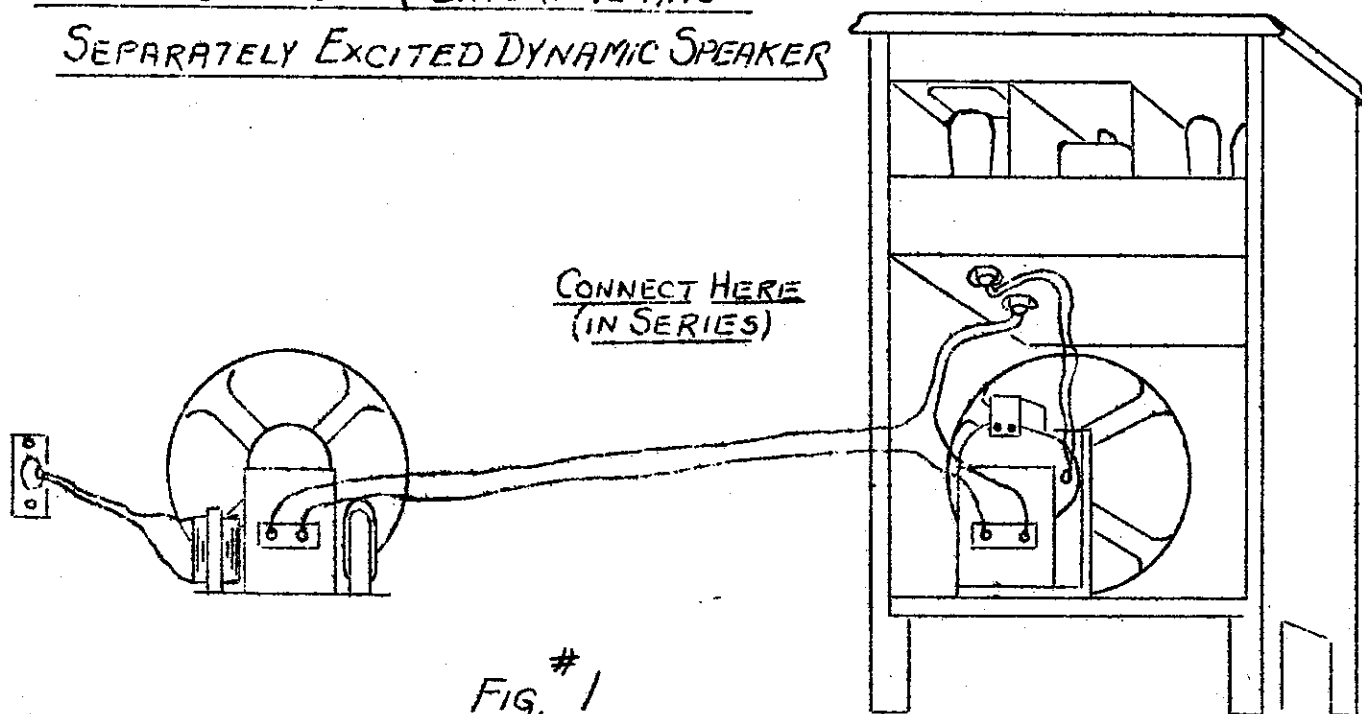
SKETCH TO ACCOMPANY BULLETIN # 7

CONNECTIONS FOR EXTERNAL AND
SEPARATELY EXCITED DYNAMIC SPEAKER

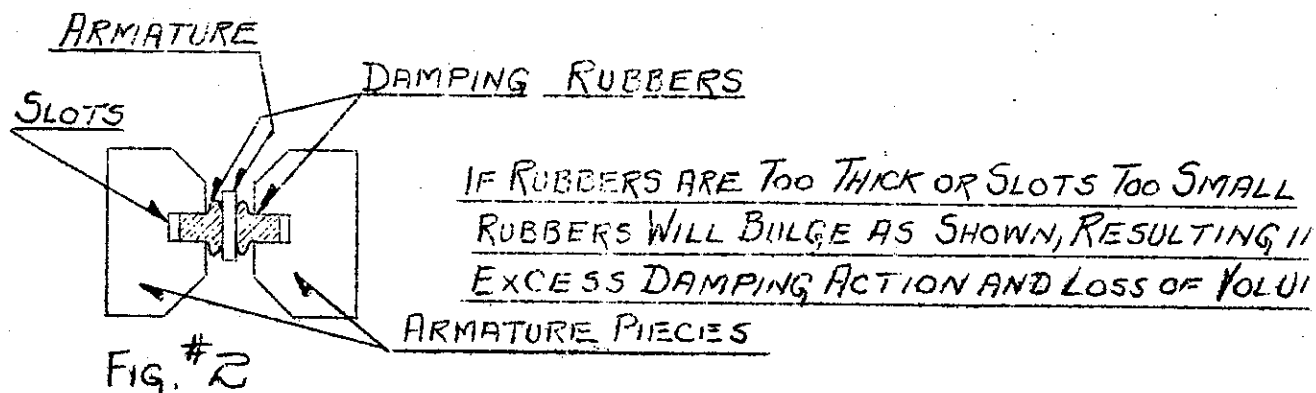
SKETCH TO ACCOMPANY BULLETIN # 8

SKETCH SHOWS CAUSE FOR LOSS OF VOLUME IN PICK-UP

(a) Excessive damping, The pole piece slots may be too small or too narrow, resulting in improper damping action or prevention of proper damping adjustment by means of the adjustment provided for this purpose. That is, damping may be increased to an excessive amount but decreased damping will not result from change in adjustments provided, the narrowed slots in pole pieces preventing damping rubber from returning or resuming its natural position in slotted recess. To correct this condition in an emergency it is recommended that pole pieces be removed and the slots widened by filing. However, great care must be exercised in this operation, using a platinum file, trying the damping rubber frequently to insure a "Snug" fit,

NOTE, - TO CORRECT THIS CONDITION WIDEN SLOTS
BY FILING SIDE WALLS, USING PLATINUM FILE OR EXTRA
FINE FILE, PERMITTING FREE MOVEMENT, IN AND OUT
OF DAMPING RUBBERS.

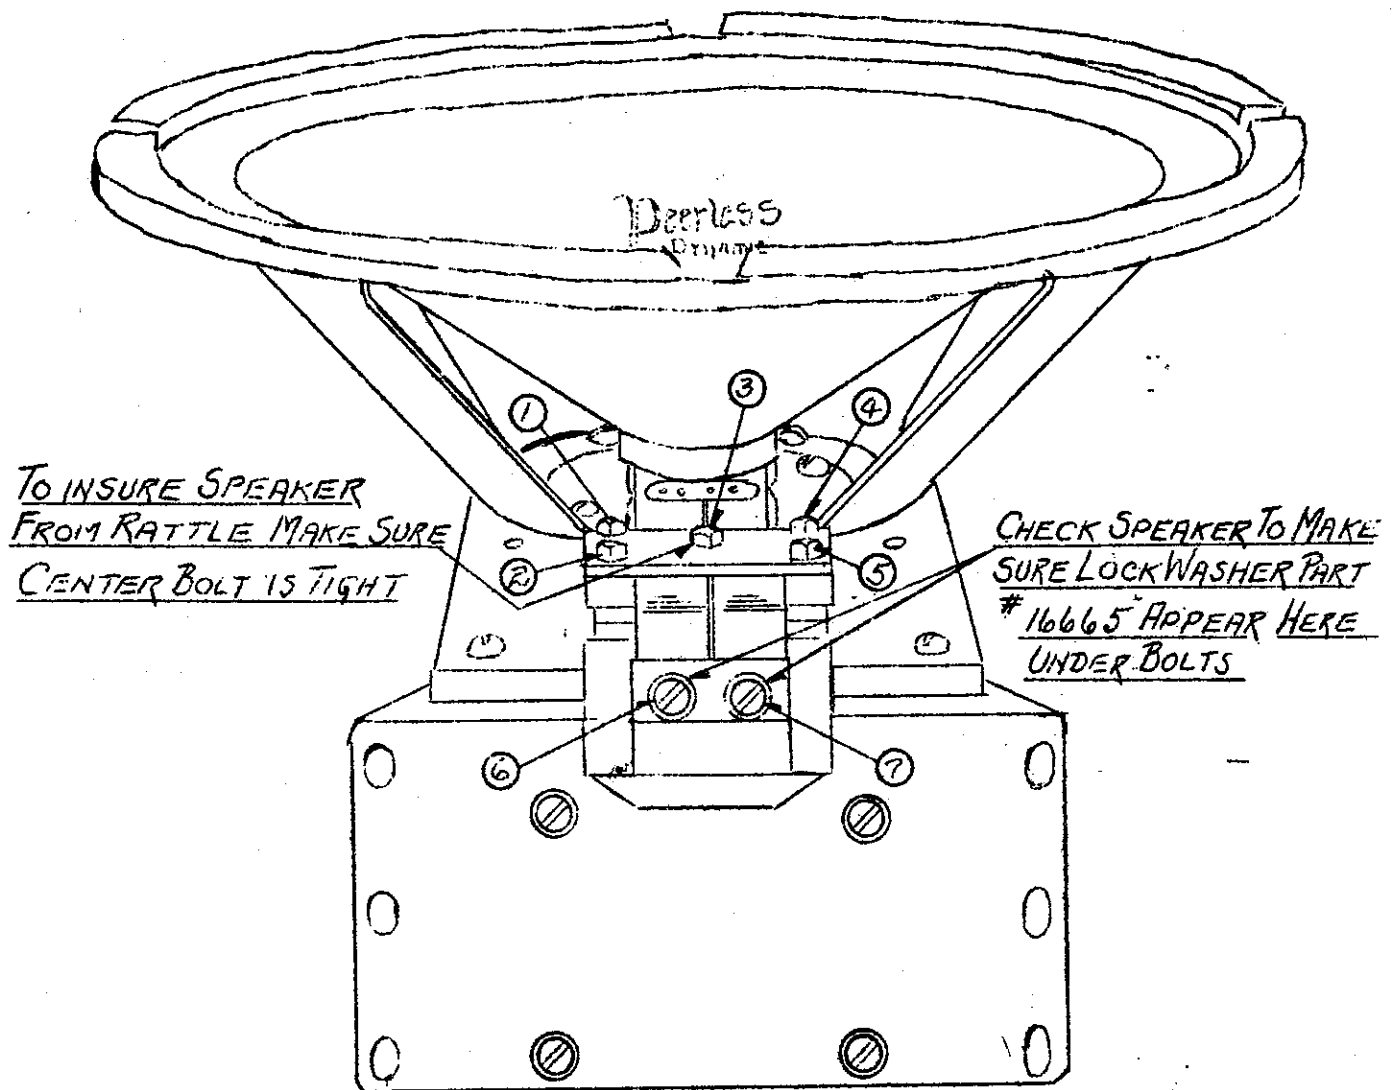
TO ACCOMPANY BULLETIN # 11

One of our field Service Engineers has been consistently reporting that he finds speaker bolts very loose. In order to get the best volume and reproduction the following bolts must be drawn up tight.

① TO ⑤ VOICE COIL HOLDING BOLTS

⑥-⑦ THESE CONTACT BOLTS MUST BE TIGHT.

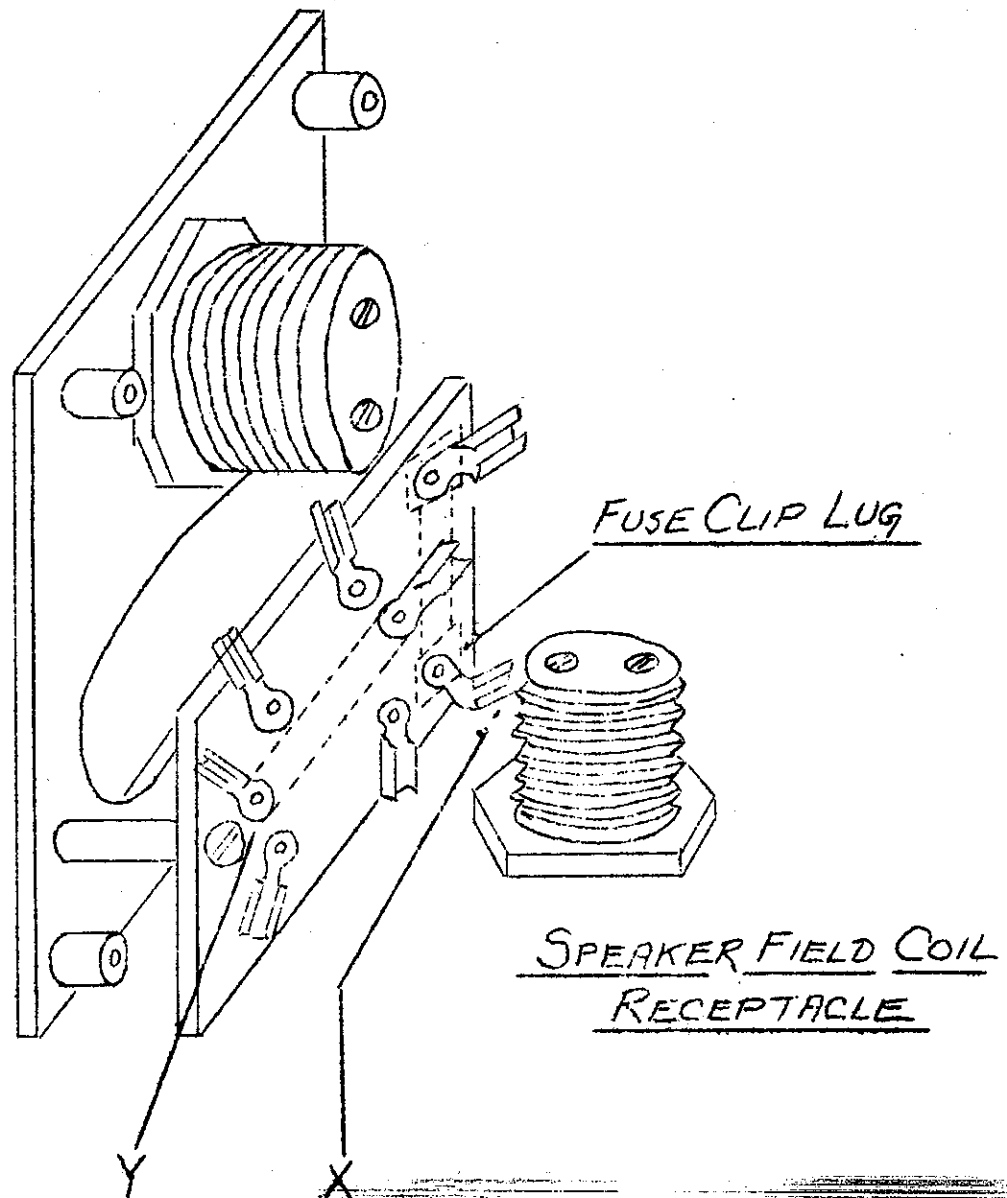
TO ACCOMPANY BULLETIN #14

2. The Attached figure indicates the location of possible short in chassis which will result in burned out primary IF THE GROUND WIRE IS ATTACHED TO ANTENNA POST OR IF ANTENNA ITSELF BECOMES GROUNDED.

4. If these grounds exist in chassis the chassis fuse will burn out repeatedly, as A.C. line plug is inserted in one position.

"BURNED OUT ANTENNA COILS"

5. By reversing the position of A. C. line plug, the fuse will not burn out--with the ground still present in chassis. However, for safety's sake we recommend removal of the ground.

7. If fuse trouble is experienced the "ground trouble" should be discovered and cured to avoid possibility of damage to antenna primary.

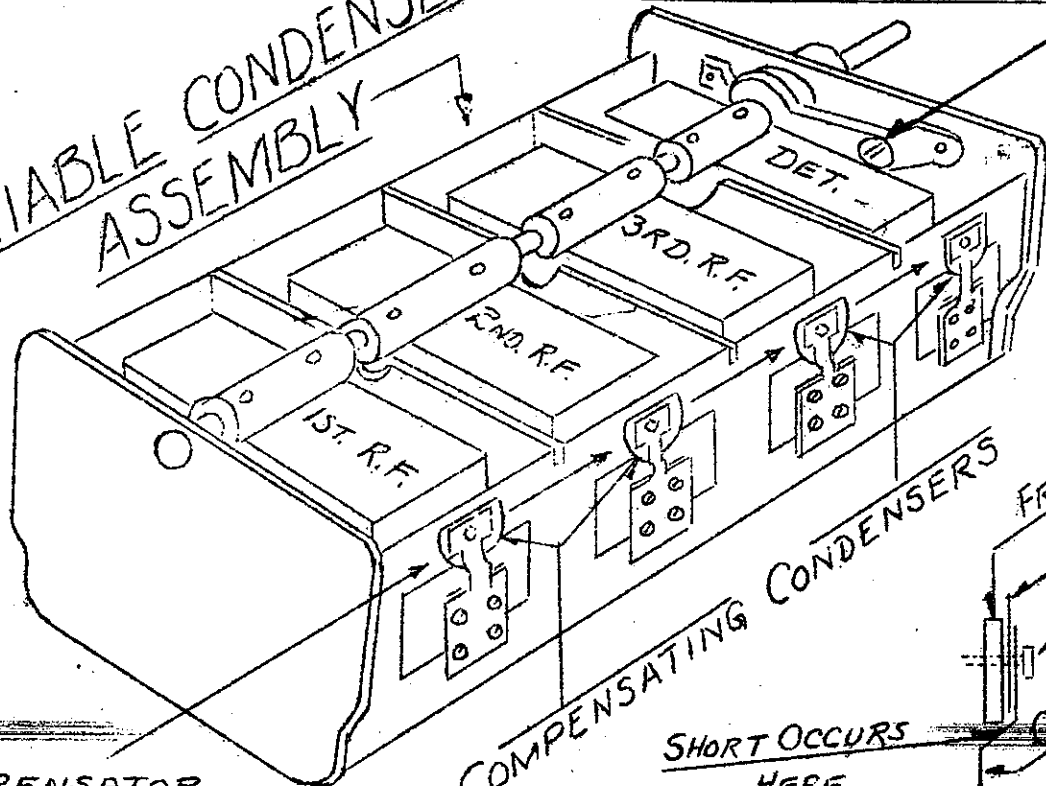
FIG. #2

NEVER TOUCH THIS SCREW

4. Move regeneration Switch to Regenerative Position. With volume control turned up as much as possible but always just below the "spilling point", use balancing tool, turning the detector compensator adjustment screw, all the way in or out to locate the point of maximum volume. As the balancing tool is removed from adjustment screw a slight decrease in volume may be noticed. If so, set up or tighten the adjustment screw a trifle until maximum volume results with balancing tool removed. This condition will hold, probably with the remaining adjustment screws.

7. It is usually well to check the detector compensator setting as a final adjustment.
8. Now tune in a high wave station between 75 and 85 on the dial, and once more go through the procedure as outlined in preceeding paragraphs 4,5,6, and 7. If you find only slight changes are necessary in compensator adjustments, set compensator adjusting screws half way between their settings for low wave and high wave. If, however, you find that it is advisable to replace the gang condenser.

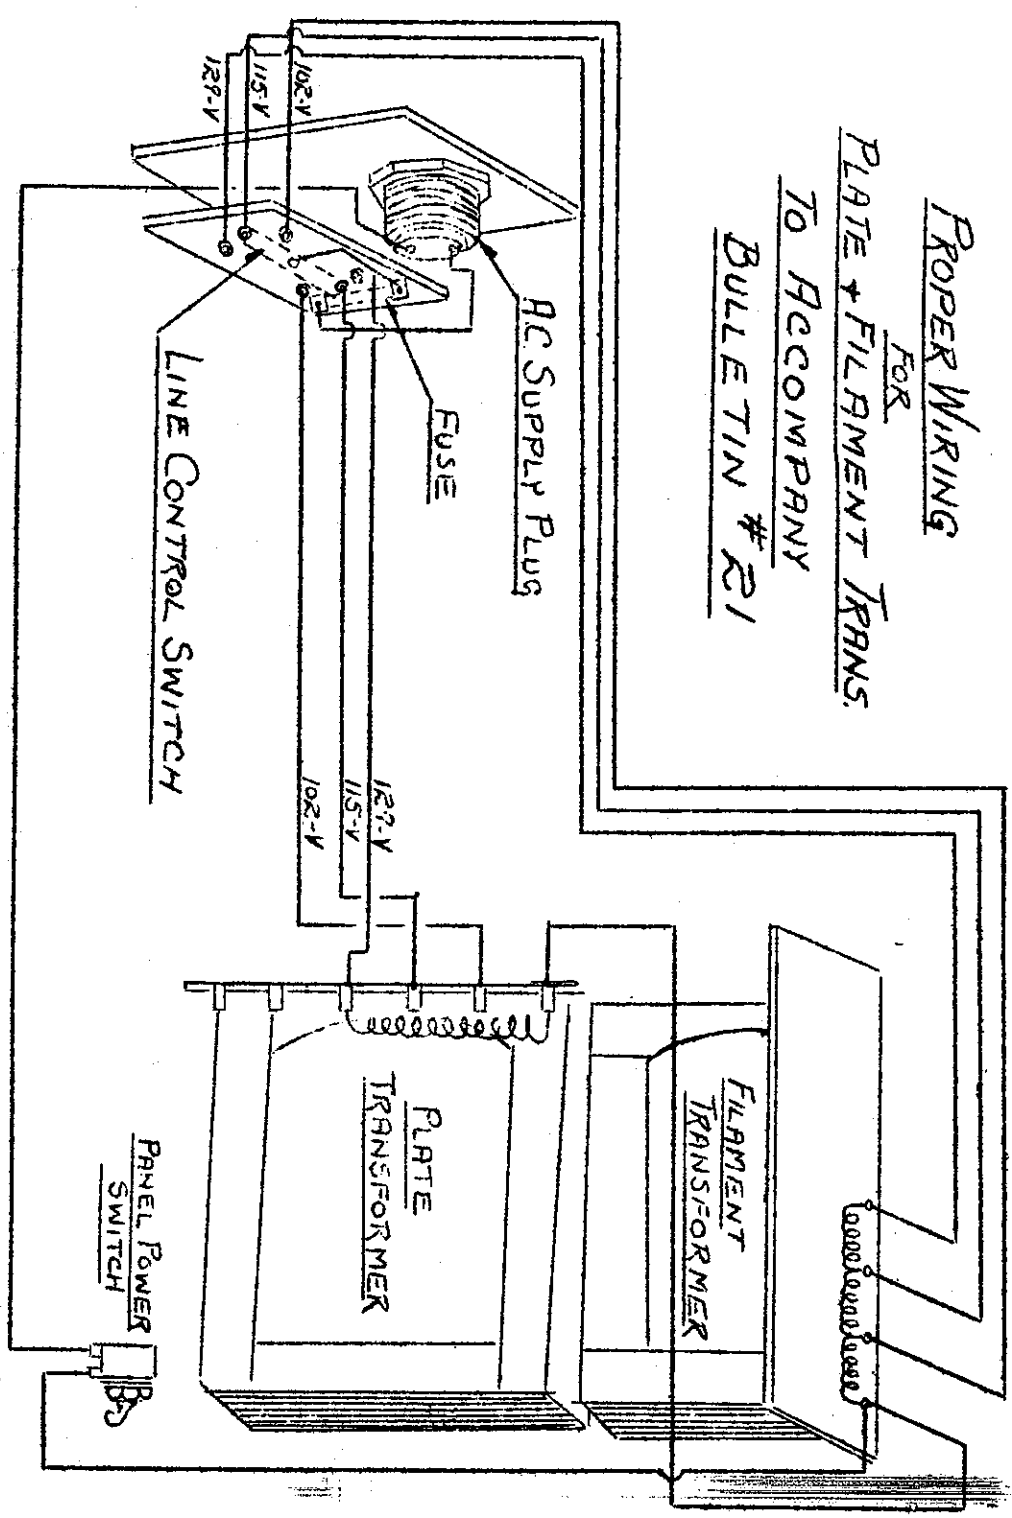
PROPER WIRING
FOR
PLATE + FILAMENT TRANS.
TO ACCOMPANY
BULLETIN # 21

SUBJECT: "Plate transformer improperly connected."

3. This condition is usually recognized by the fact that the Set, instead of stopping immediately when shut off continues to play for a few seconds, or in other words, as long as the filament holds sufficient heat to operate.

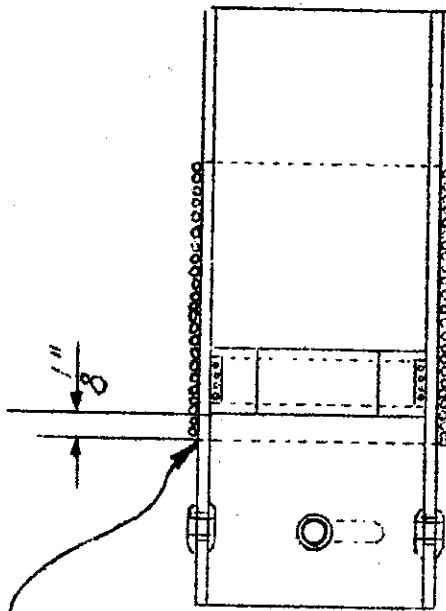
SHOWING CHANGE IN R.F. PRIM. COILS
TO ACCOMPANY BULLETIN # 24

SHOWING CHANGE IN
POSITION OF P.F. PRIM COILS

2. To do this invert the chassis, remove the shield "holding clamps" and take off the cover of each shield. The primary spools are then in plain sight and by tapping them gently with a screw driver, they will break away from the amberoid cement that holds them in place. It is then an easy matter to push them 1/8" further into the secondary coil and fasten in place with amberoid cement. However, care must be taken so that none of the wires are broken. Shifting Primary coils results in greater signal strength on weak stations.

NOTE, BOTTOM OF PRIM.
COIL SHOULD BE $\frac{1}{8}$ " ABOVE
THE BOTTOM OF SECONDARY
WINDING AS SHOWN

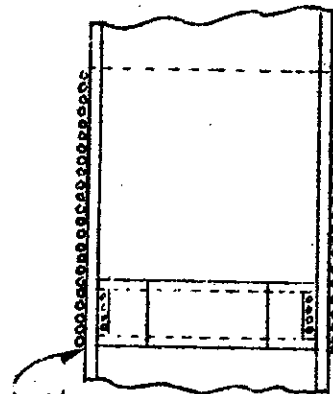
SHOWING ORIGINAL
POSITION OF R.F. PRIM. COILS

NOTE, - BOTTOM OF PRIM COIL
SPOOL IS FLUSH WITH BOTTOM
OF SECONDARY WINDING.
